TRANSMISSION D I G E S T

• **Subject:**
Leak caused by reusing pan gasket

• **Unit:**
6R140W

Reusable Gasket – Not!

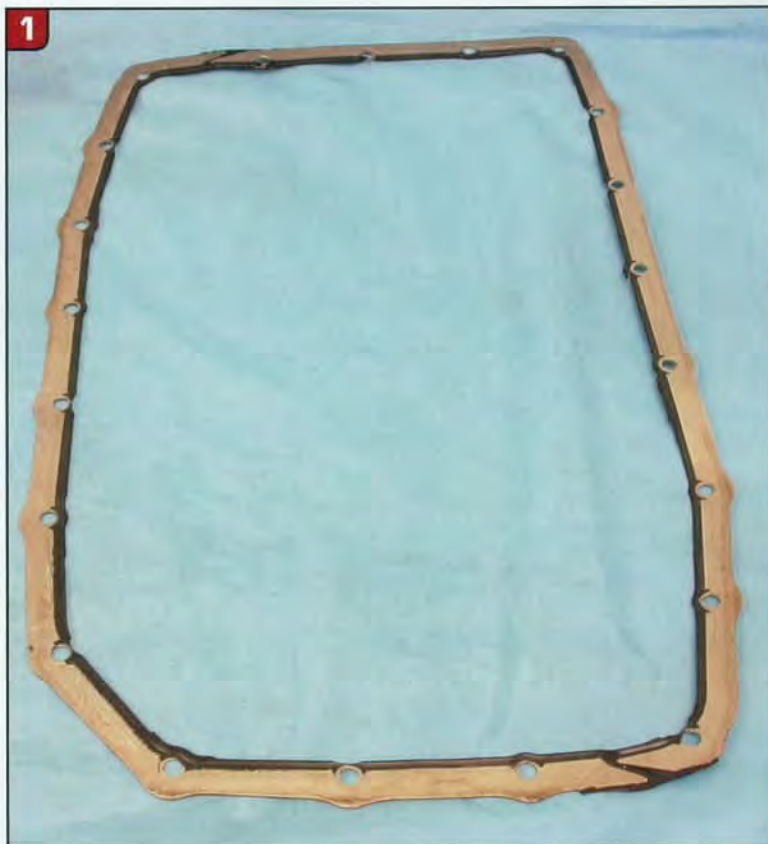
The so-called reusable pan gasket (**Figure 1**) is actually the cause of the problem. A closer look at the bolt-hole area in **Figure 2** shows that part of the rubber sealing material has eroded away and is allowing transmission fluid to leak from the pan gasket. If the gasket were allowed to leak anywhere other than from the front, it would immediately be recognized as a pan-gasket leak or per-

The part number for a new pan gasket is 6L2Z-7A191-BA.

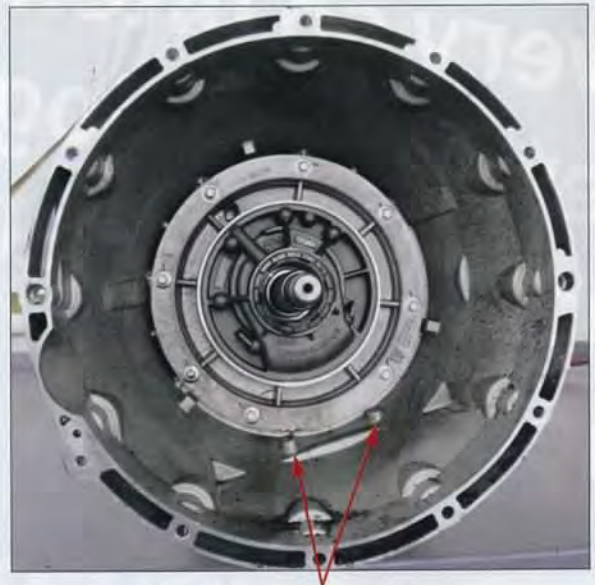
3

But in this situation it was leaking from the areas of the front two pan-bolt holes. In **Figure 3** you can see that the two front pan-bolt holes are drilled through into the inside of the bellhousing area.

Because the fluid level is above this area when the transmission is full, fluid was leaking from these bolt holes, creating the illusion that the transmission was leaking from the front. Since this incident occurred, I have seen this happen again. Needless to say, the technicians in these shops will never reuse one of these pan gaskets again; you may wish to do the same.

Front pan bolts are drilled through into bellhousing area

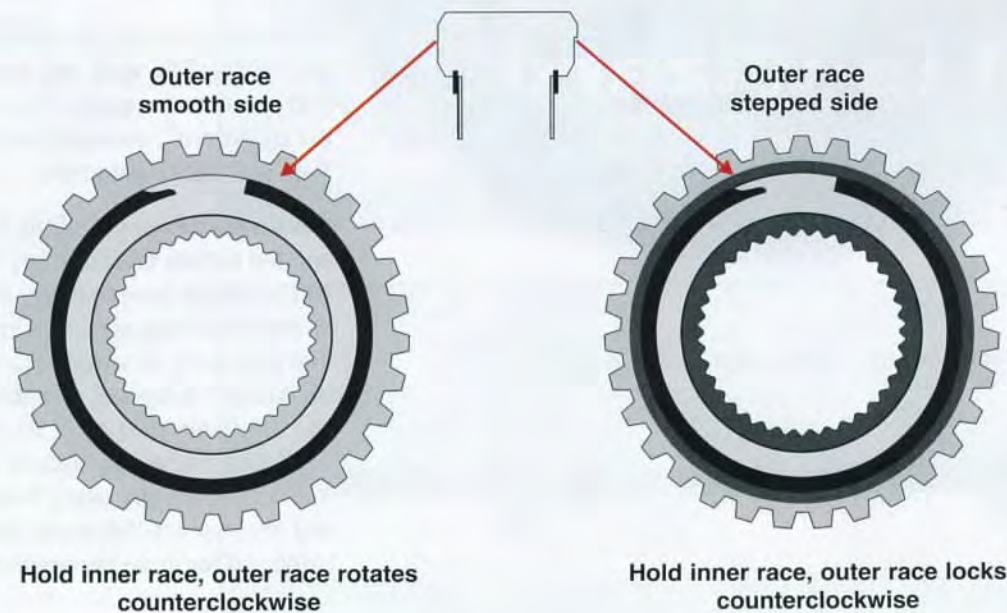
In the Shift Pointers article in the March issue, there was an error in Figure 11 on page 10. The explanations under the two depictions of the sprag should

have read "counterclockwise" instead of "clockwise." All other text and photographs in the article were accurate. Here is the corrected illustration.

One-way-clutch (overrun sprag) freewheel and hold
