## Reason for installing a PML 11036 transmission pan on my 2010 GMC Savana 3500:

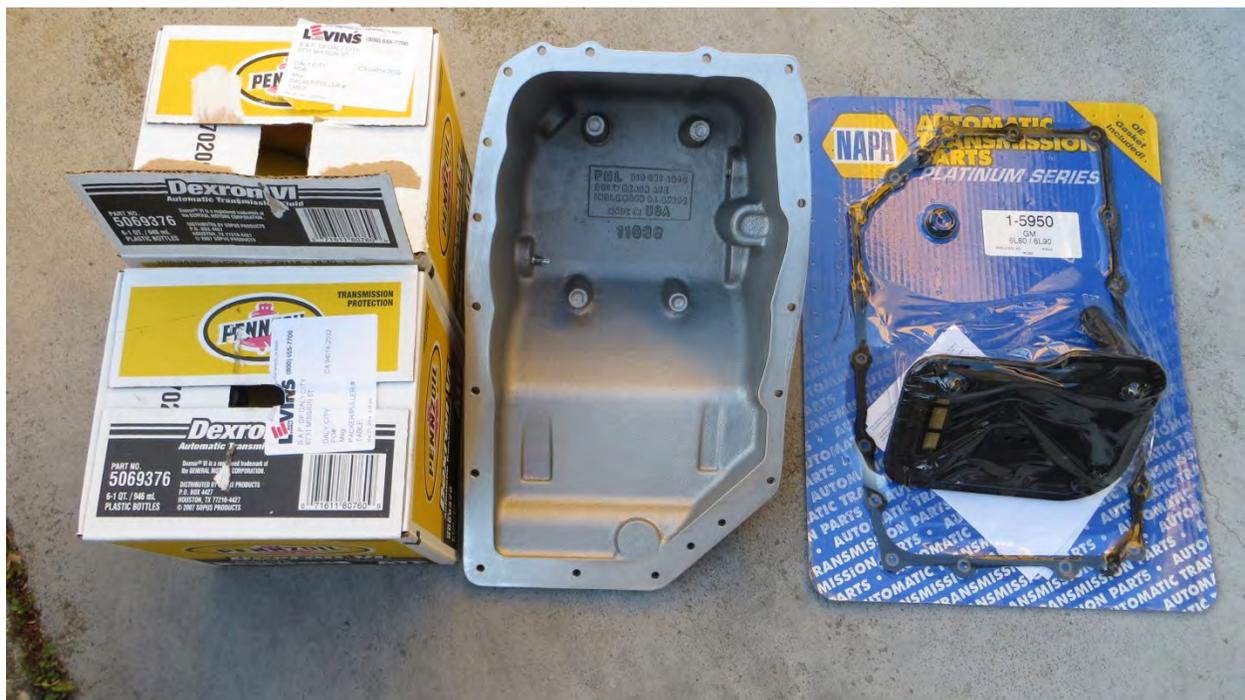
1. A 10 millimeter socket and wrench to remove the existing hardware securing the oil pan.
2. A 5 millimeter Allen wrench to install the new oil pan.
3. An oil drain pan to catch the existing 8 quarts of oil during the pan's removal.
4. A transmission jack, transmission stand or ramp to safely perform this maintenance.
5. 11 quarts of Dexron VI oil.
6. A new transmission filter and gasket. In this case, I purchased a NAPA 1-5950 kit.
7. A PML 11036 transmission pan.

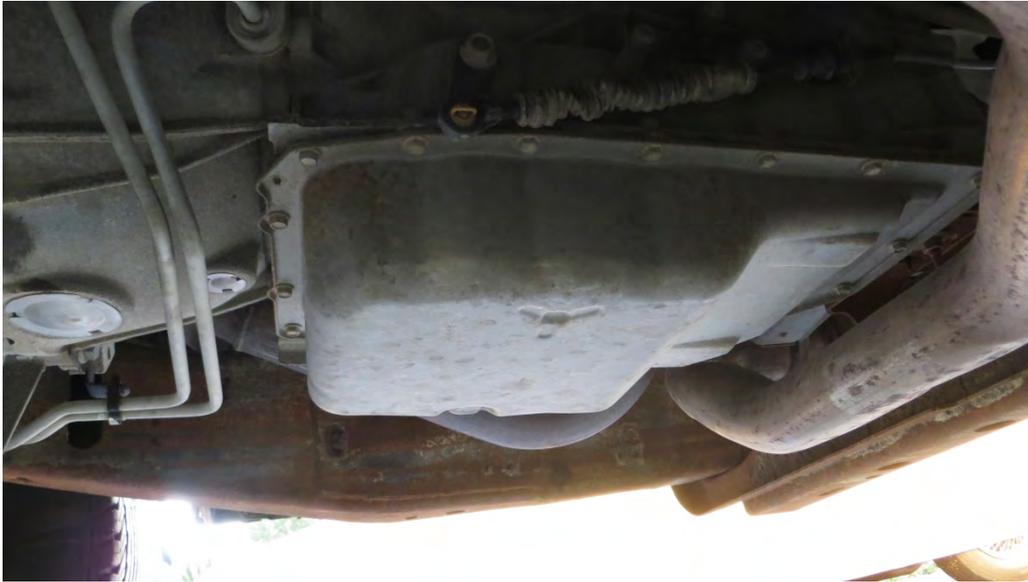
1. Remove the 14 of the 18, 10 millimeter bolts securing the existing factory transmission pan with a socket and ratchet. The three bolts towards the rear adjacent to exhaust pipe will require a 10 millimeter wrench to remove.

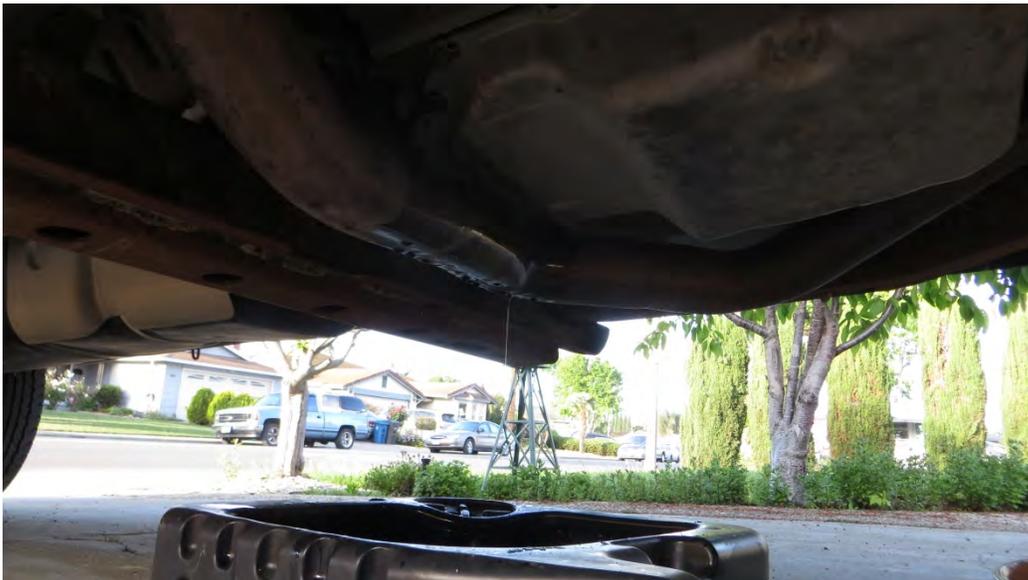
2. Allow 4 of the 18, 10 millimeter bolts to be removed to remain loosely in each corner, so the fluid can be allow to drain onto the oil drain pan below.

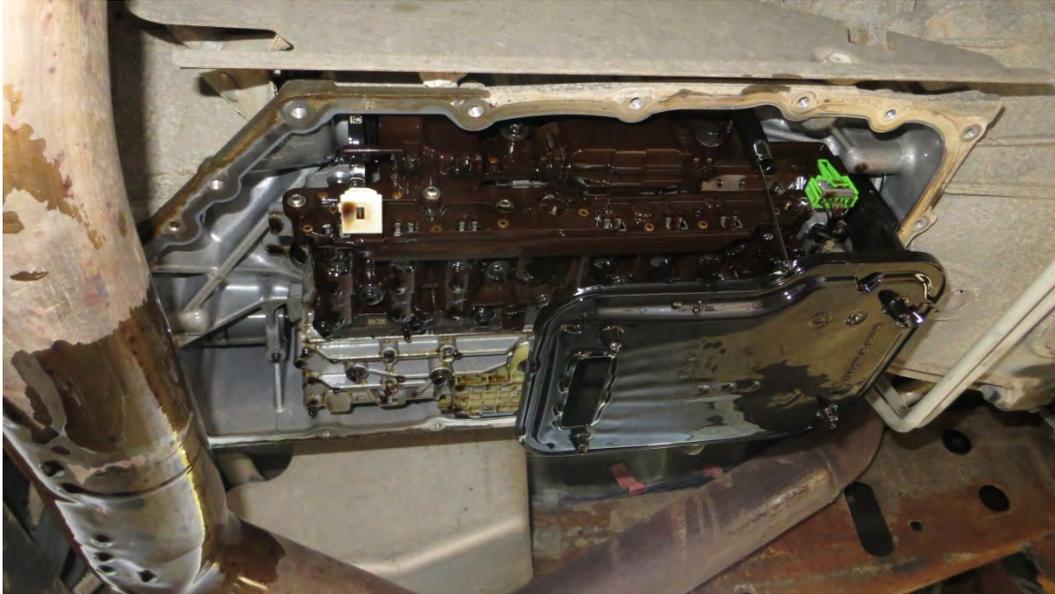
3. Remove move the old transmission filter and install the new replacement unit. There are no tools needed for this process. It is merely a push fit installation.

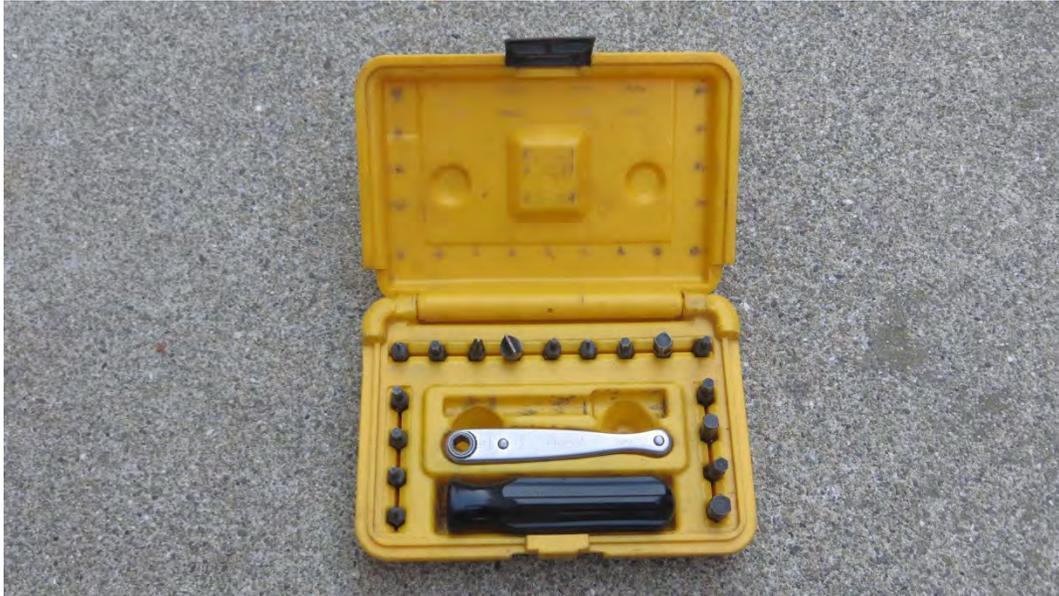
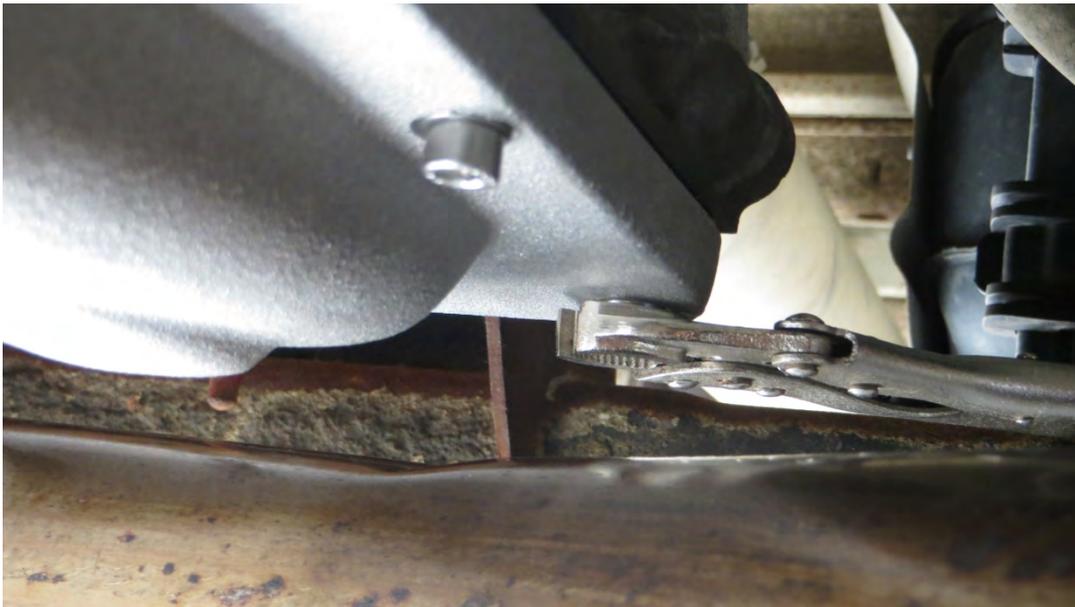
6. Toward the rear of the oil pan is where I encounter my first problem. It seems the three bolts securing location towards the rear of the transmission pan by the exhaust had a clearance issue which prevented the proper torqueing of supplied hardware. There was simply no clearance to attach a 5 millimeter allen wrench to the bolt heads to torque it. Normally a Chapman allen set will resolve this type of mechanical issue (as these tools are made to resolve clearance issue), but even that did not work. Eventually, I resorted to using a mini vise grip to torque these remaining fasteners in place. Not a great feeling to do this, but that was the only option I had at the time to get my vehicle back on the road. I will eventually replace these three fasteners with a hex head style bolts like the factory originally had, so I can properly secure it. There must have been a good reason why the OEM chose that style of hardware. In any case, this was not a big setback, but it did slow the installation process down a bit.
